DAM SAFETY INSPECTION REPORT

RUNYAN LAKE DAM DAM INVENTORY NO. 1981 LIVINGSTON COUNTY, MICHIGAN

July 21, 2009

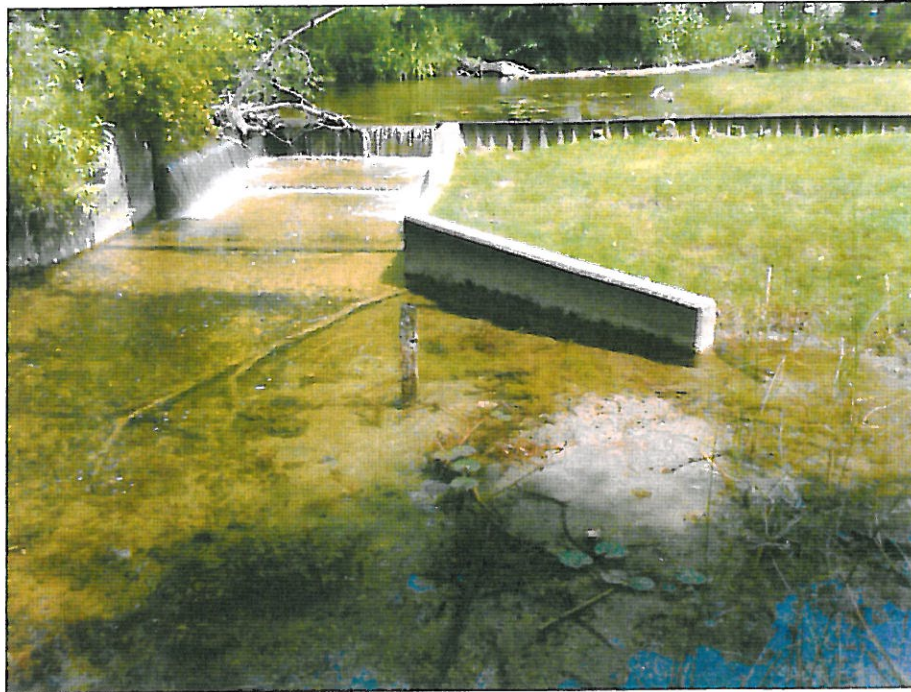
AT DAM LOOKING EAST TOWARD RUNYAN LAKE

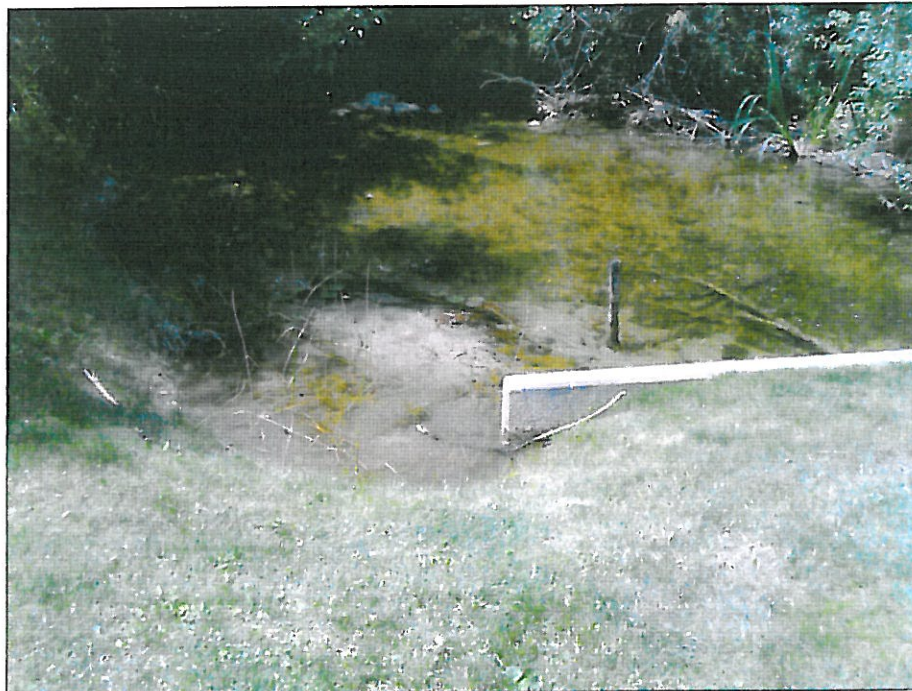
AT DAM LOOKING WEST TOWARDS OUTLET

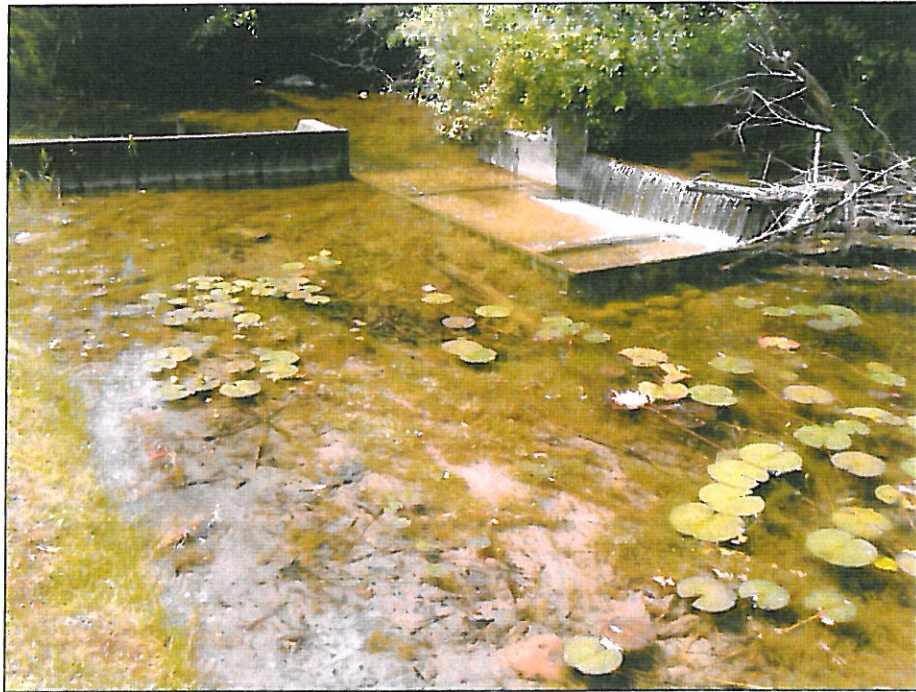
LOOKING WEST TOWARD DAM

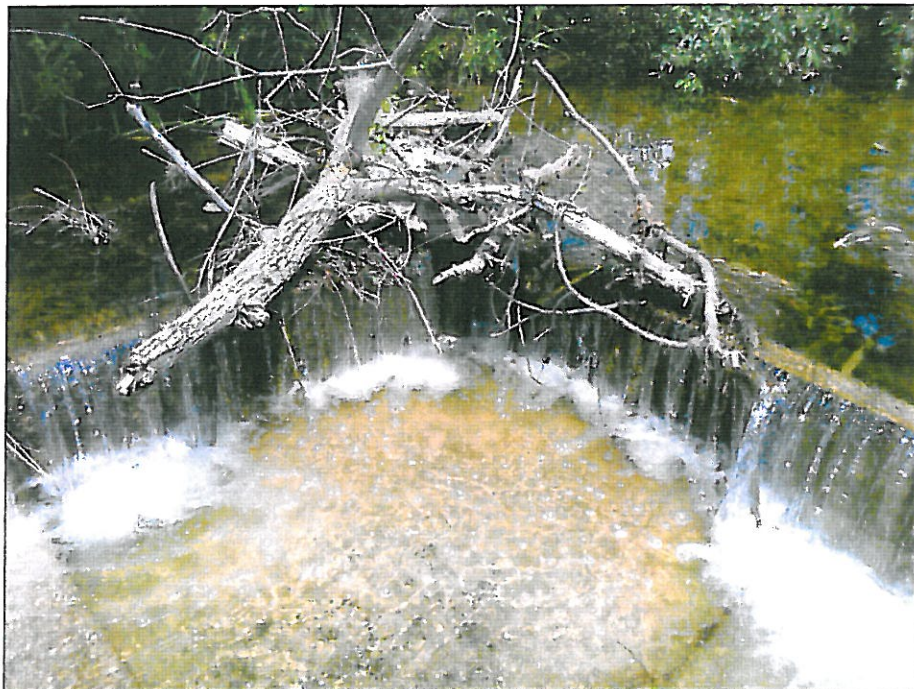
INLET	OUTLET
SIZE	±30 Ft Wide	±10 Ft Wide
EXISTING CONDITION	Good	Good
EROSION	None	None
DEBRIS & OBSTRUCTIONS	Tree limb hung up on weir	None
RIPRAP PROTECTION	None	None
REMARKS*	Remove tree limb hung up on weir	Rip rap will help stabilize slope at wingwalls

AT DAM LOOKING NORTH TOWARD DEBRIS ON WEIR

Remove tree limb hung up on weir and any natural vegetation and add rip rap at concrete wingwalls.
