RUNYAN LAKE MANAGEMENT PLAN STUDY FINDINGS AND CONCLUSIONS

**RUNYAN LAKE
PHYSICAL CHARACTERISTICS**

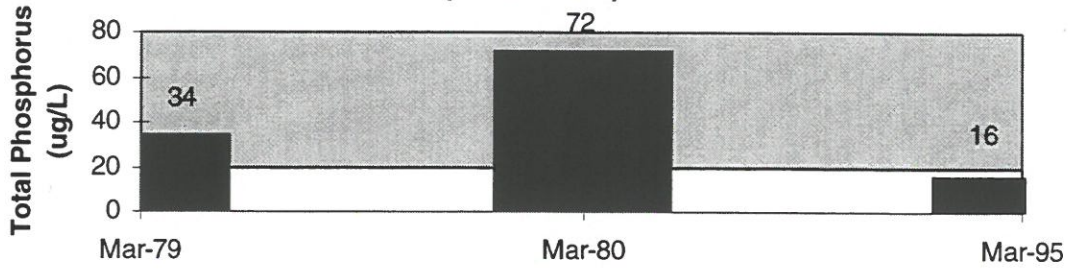
**Average Spring Total Phosphorus Concentrations
(1979-1995)**

Runyan Lake water quality data. The shaded areas show the level at which water quality problems typically begin to occur.

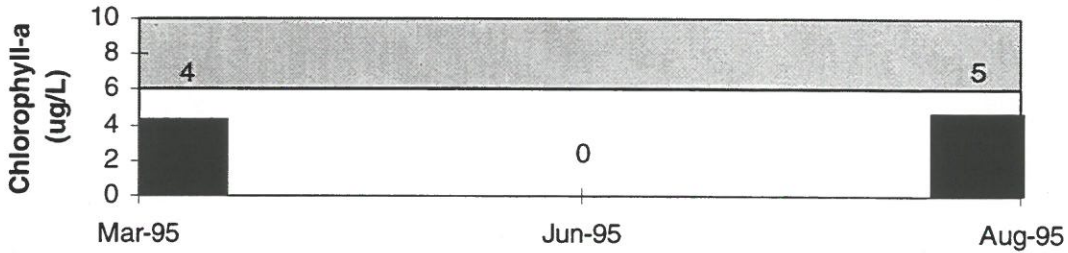
**Average Chlorophyll-a Concentrations
(1995)**

Chlorophyll-a is the pigment that makes plants green in color. A rough estimate of the quantity of algae in lake water can be made by measuring the amount of chlorophyll-a in a water sample.

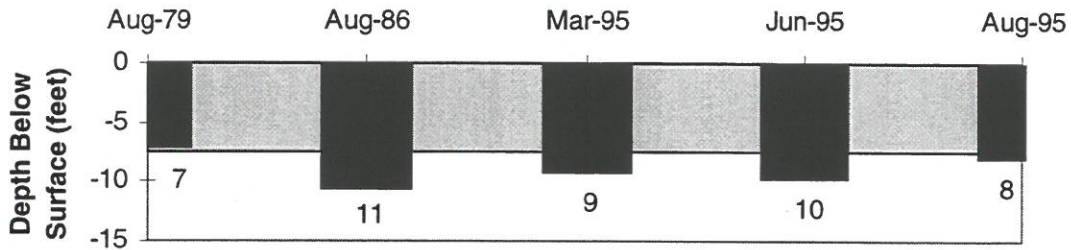
**Average Secchi Transparency
(1979-1995)**

A Secchi disk is a flat, circular disk, 8 inches in diameter, the surface of which is divided into 4 pie-shaped sections with the alternating sections painted black and white. The Secchi disk is used to estimate water clarity.
