RUNYAN LAKE
LAKE MANAGEMENT STUDY REPORT

August 1996

Runyan Lake Inc.

Project No: 9503-26

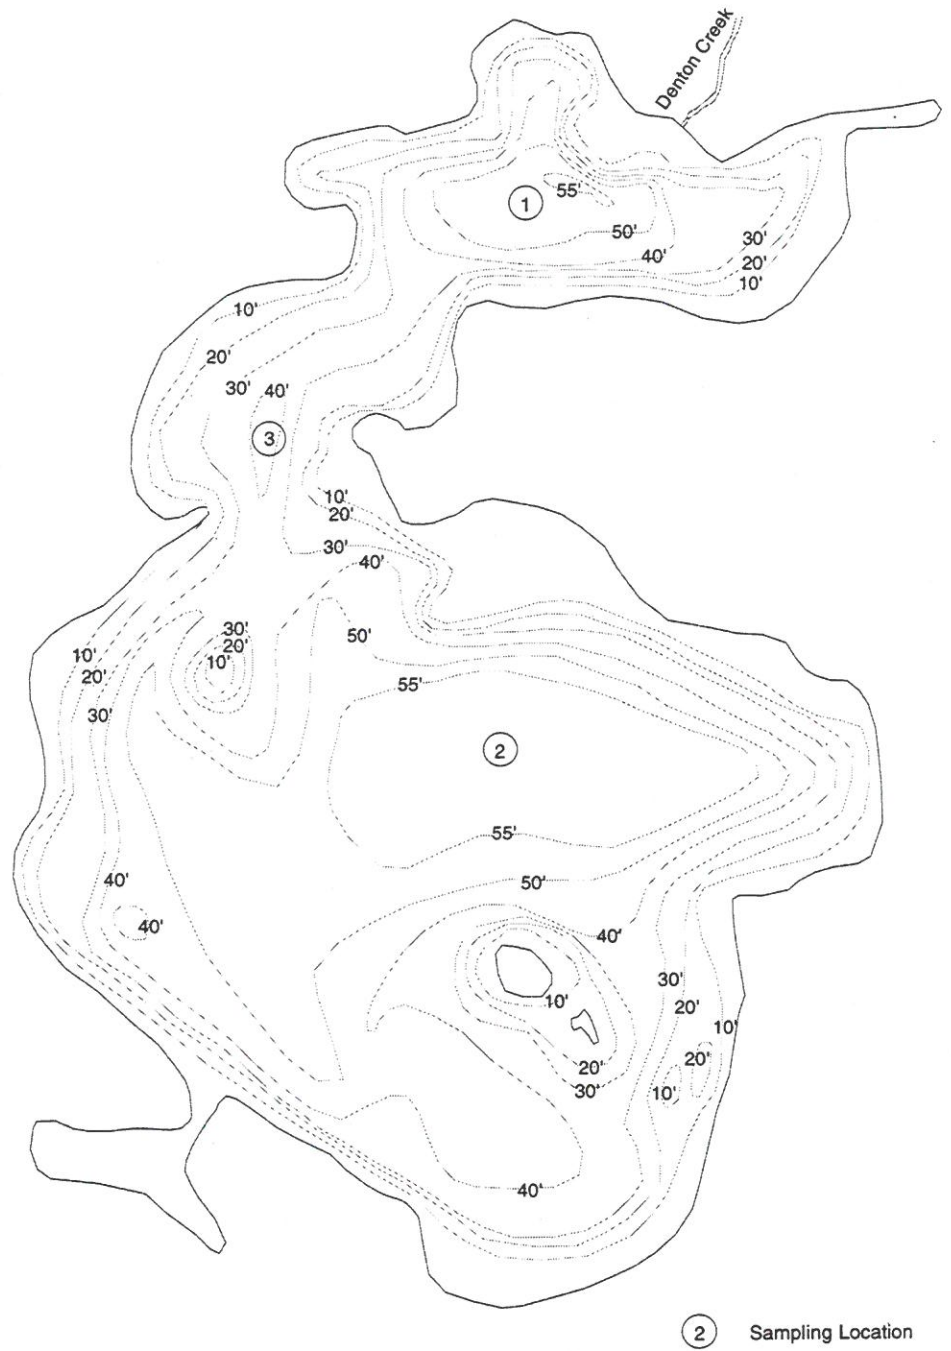
Figure 4. Deep Basin Sampling Location Map.

Samples were collected from the surface to the bottom at each of the three deep basins of Runyan Lake on March 28, June 21, and August 14, 1995 (Figure 4). These sampling periods corresponded with spring turnover, early-summer stratification, and late-summer stratification, respectively.

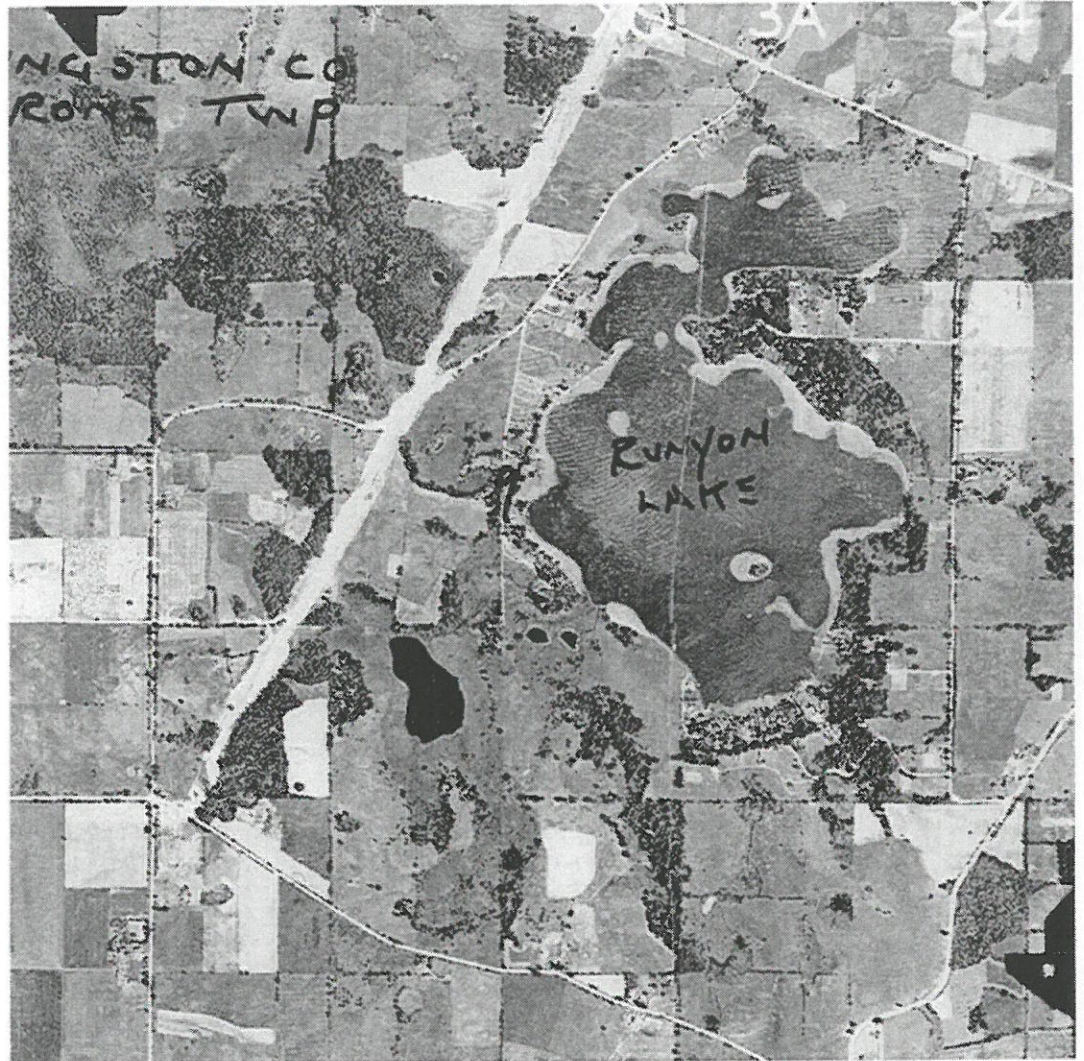
Figure 7. Runyan Lake area, 1940.

A review of historical aerial photographs of the Runyan Lake area (Figures 7 thru 9) reveals that development around the lake increased dramatically between 1940 and 1980. In 1940, Runyan Lake had only about 75 homes around the lake and the Fenton Highway (west of lake) was still under construction. By 1955, the lake perimeter contained approximately 120 homes and in 1957, U.S. 23 was constructed immediately west of the lake. The construction of U.S. 23 greatly increased the accessibility of Runyan Lake and thus made it more attractive for residential development. The excavation of the cove at the southwest end of the lake and the canal at the northeast corner of the lake occurred between 1955 and 1963. By 1980, approximately 180 homes bordered the lake and, at present, 226 homes abut the lake. Thus, in a 56-year period, shoreline development around Runyan Lake increased by 200 percent. As natural groundcover and wetlands in the area were replaced by roof tops, roads, and other impervious surfaces, water runoff to the lake increased as the quality decreased. Clearly, this has had a direct impact on the quality of Runyan Lake especially in the near-shore areas where excessive aquatic vegetation is most prevalent.
