## Runyan Lake Water Quality Update and Management Recommendations

Progressive AE  
1811 4 Mile Road, NE  
Grand Rapids, MI 49525-2442  
616/361-2664

**May 2005**

**Project No: 58400101**

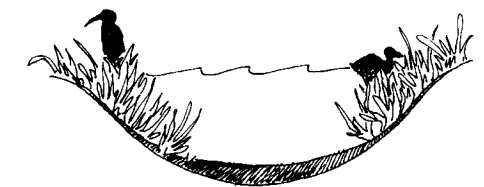
Lakes are commonly classified as **oligotrophic**, **mesotrophic**, or **eutrophic**. Oligotrophic lakes are generally deep and clear with little aquatic plant growth. These lakes maintain sufficient dissolved oxygen in the cool, deep bottom waters during late summer to support cold water fish such as trout and whitefish. By contrast, eutrophic lakes are generally shallow, turbid, and support abundant aquatic plant growth. In deep eutrophic lakes, the cool bottom waters usually contain little or no dissolved oxygen. Therefore, these lakes can only support warm water fish such as bass and pike. Lakes that fall between these two extremes are called mesotrophic lakes.

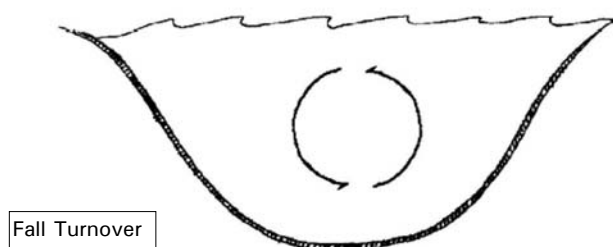
An important factor influencing lake water quality is the quantity of **dissolved oxygen** in the water column. The major inputs of dissolved oxygen to lakes are the atmosphere and photosynthetic activity by aquatic plants. An oxygen level of about 5 mg/L (milligrams per liter, or parts per million) is required to support warm water fish. In lakes deep

enough to exhibit thermal stratification, oxygen levels are often reduced or depleted below the thermocline once the lake has stratified. This is because deep water is cut off from plant photosynthesis and the atmosphere, and oxygen is consumed by bacteria that use oxygen as they decompose organic matter (plant and animal remains) at the bottom of the lake. Bottom-water oxygen depletion is a common occurrence in eutrophic and some mesotrophic lakes. Thus, eutrophic and most mesotrophic lakes cannot support cold water fish because the cool, deep water (that the fish require to live) does not contain sufficient oxygen.

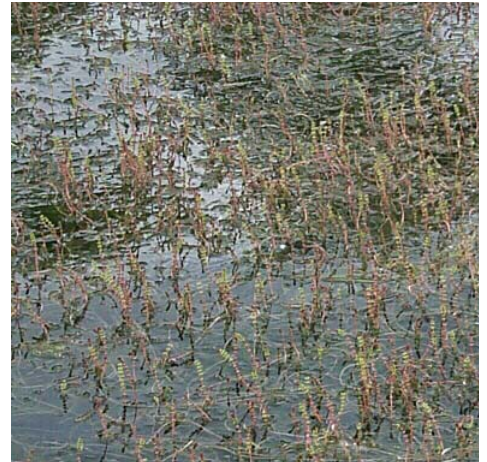
It should be noted, however, that attempts to control certain plant types by harvesting alone may not prove entirely effective. This is especially true with Eurasian milfoil (*Myriophyllum spicatum*) due to the fact that this plant may proliferate and spread via vegetative propagation (small pieces break off, take root, and grow) if the plant is cut (Figure 6). Eurasian milfoil is especially problematic in that it often becomes established early in the growing season and can grow at greater depths than most plants. Eurasian milfoil often forms a thick canopy at the lake surface that can degrade fish habitat and seriously hinder recreational activity (Figure 6). Once introduced into a lake system, Eurasian milfoil may out-compete and displace more desirable plants and become the dominant species. When Eurasian milfoil is present, it may be possible to control the growth and spread of the plant by treating the lake with a species-selective systemic herbicide. In Michigan, Act 368 of 1978 (the Public Health Code) requires that a permit be acquired from the Department of Environmental Quality before any herbicides are applied to inland lakes. The permit will include a list of herbicides that are approved for use in the lake, respective dose rates, use restrictions, and will show specific areas in the lake where treatments are allowed.

**Figure 6. Eurasian milfoil.** Inset, below right: Eurasian milfoil canopy.

Currently, nuisance aquatic plant growth occurs only in small, localized areas of the lake (approximately 15 to 20 acres total). Mechanical harvesting, manual removal (raking or pulling the plants out), or the small scale use of herbicides in these areas may be necessary to alleviate nuisance conditions. However, the large scale use of broad spectrum contact herbicides should be avoided in order to preserve fishery habitat and to maintain Runyan Lake's natural ability to fend off invasive exotic species such as Eurasian milfoil and curly-leaf pondweed (*Potamogeton crispus*). Areas found to be infested with Eurasian milfoil should be treated with a selective systemic herbicide, such as 2,4-D or Renovate (triclopyr).

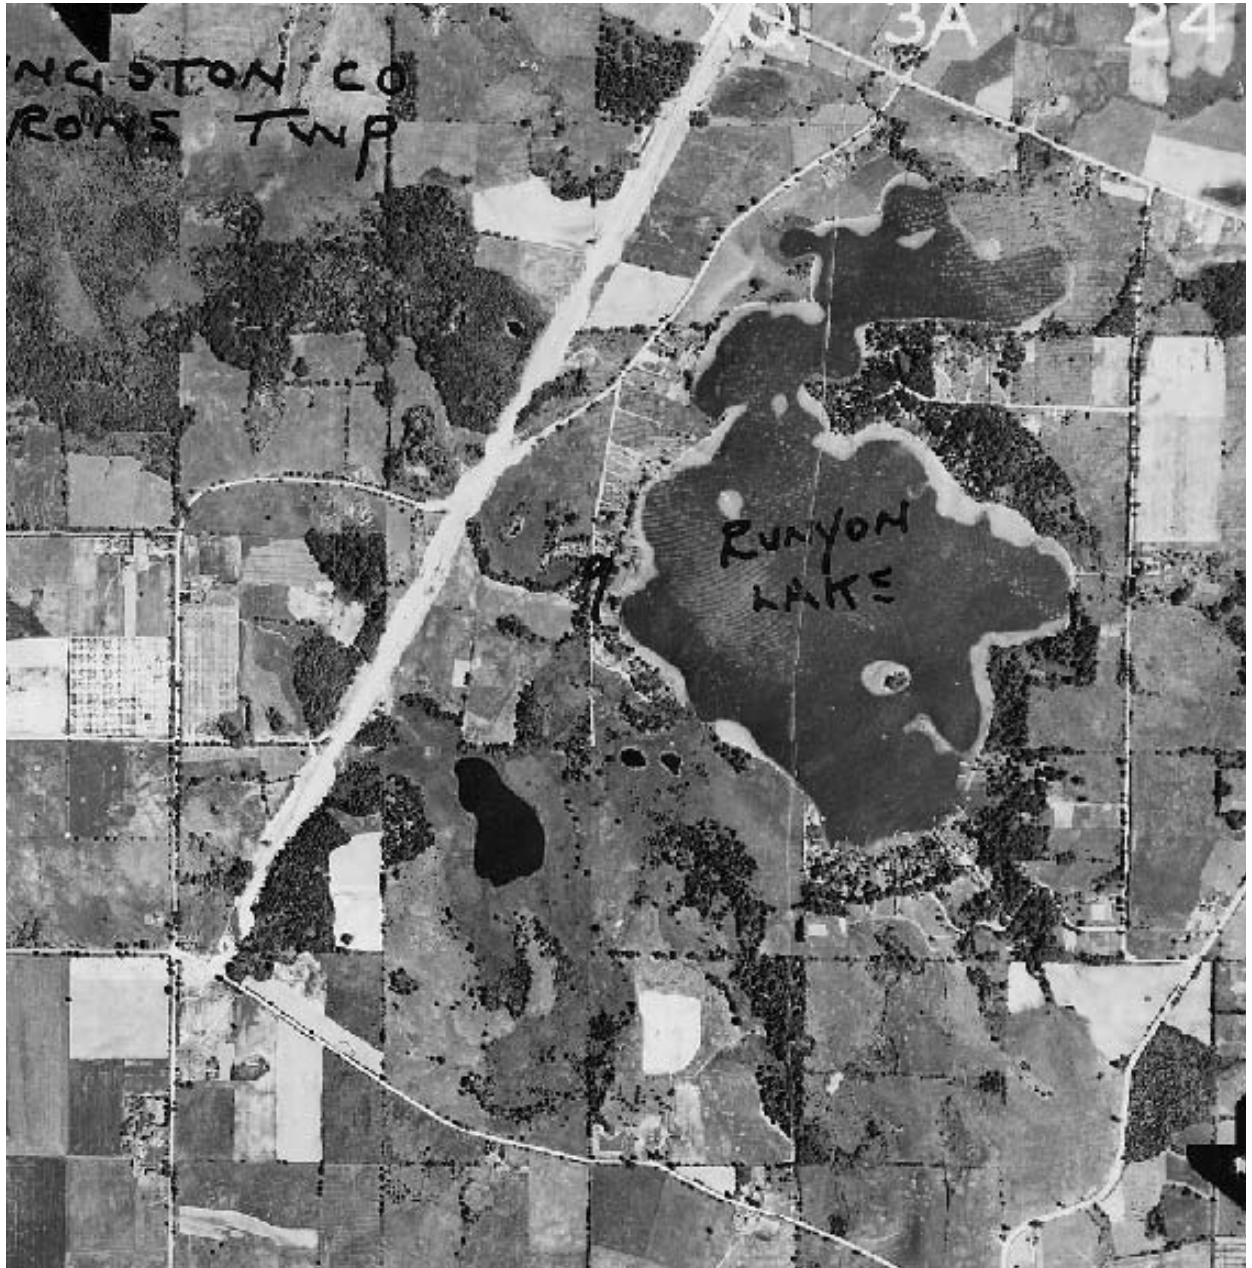
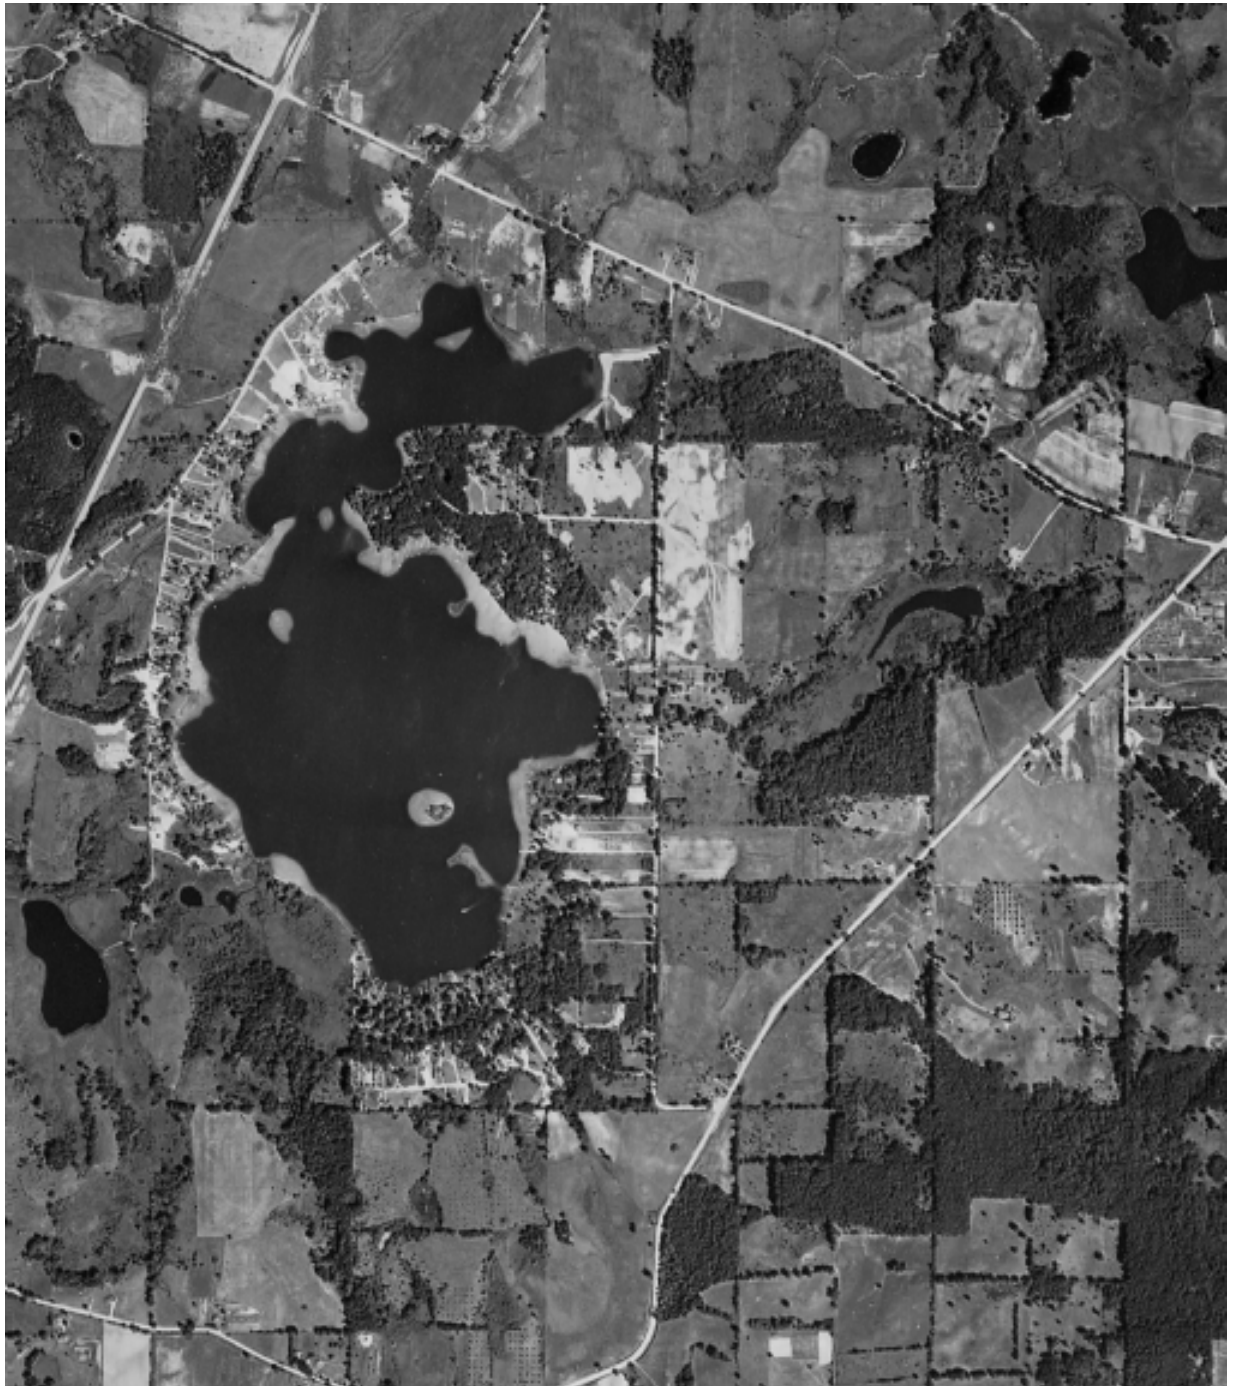
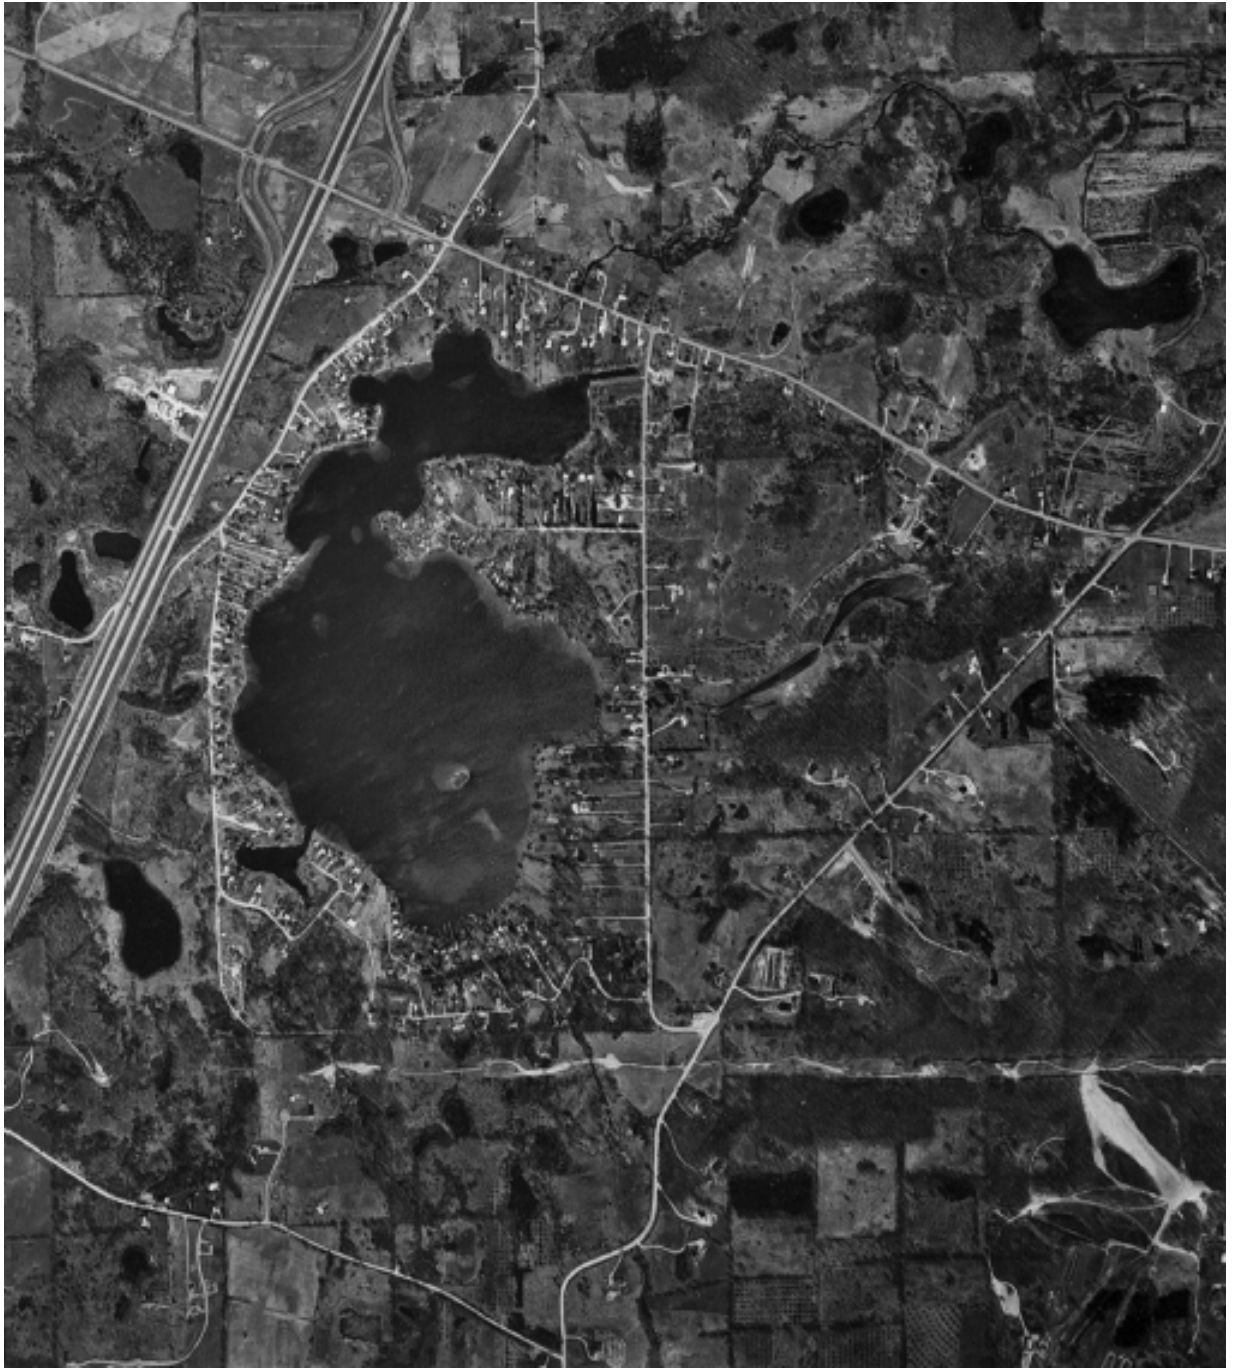
A review of historical aerial photographs of the Runyan Lake area (Figures 7 thru 9) reveals that development around the lake increased dramatically between 1940 and 1980. In 1940, Runyan Lake had only about 75 homes around the lake, and the Fenton Highway (west of the lake) was still under construction. By 1955, the lake perimeter contained approximately 120 homes, and in 1957, US-23 was constructed immediately west of the lake. The construction of US-23 greatly increased the accessibility of Runyan Lake and thus made it more attractive for residential development. The excavation of the cove at the southwest end of the lake and the canal at the northeast corner of the lake occurred between 1955 and 1963. By 1980, approximately 180 homes bordered the lake and, at present, approximately 230 homes abut the lake. As natural groundcover and wetlands in the area were replaced by rooftops, roads, and other impervious surfaces, water runoff to the lake increased as the quality likely decreased. Clearly, development in the area has had a direct impact on the quality of Runyan Lake, especially in the near-shore areas.
