DAM SAFETY INSPECTION REPORT

RUNYAN LAKE DAM DAM INVENTORY NO. 1981 LIVINGSTON COUNTY, MICHIGAN

July 21, 2009

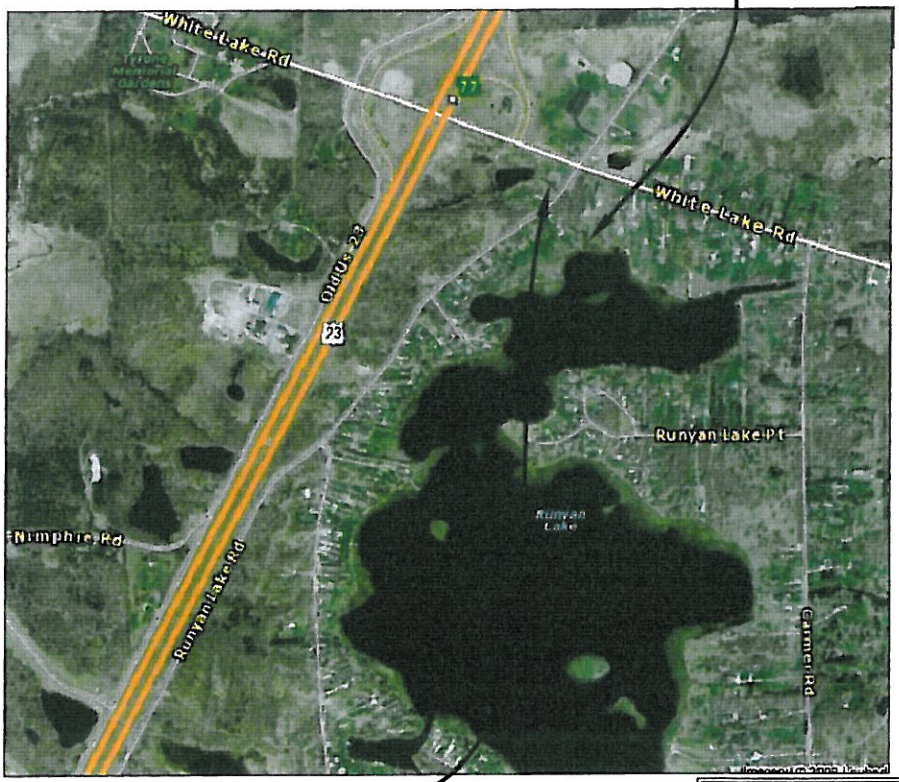
OUTLET CHANNEL

INLET	OUTLET
SIZE	±30 Ft Wide	±10 Ft Wide
EXISTING CONDITION	Good	Good
EROSION	None	None
DEBRIS & OBSTRUCTIONS	Tree limb hung up on weir	None
RIPRAP PROTECTION	None	None
REMARKS*	Remove tree limb hung up on weir	Rip rap will help stabilize slope at wingwalls
